US Army Corps  
of Engineers®  
Engineer Research and  
Development Center

## **Periodic Inspections of Hilo, Kahului, Laupahoehoe, and Nawiliwili Breakwaters, Hawaii**

Armor Unit Monitoring for Period 2001-2005

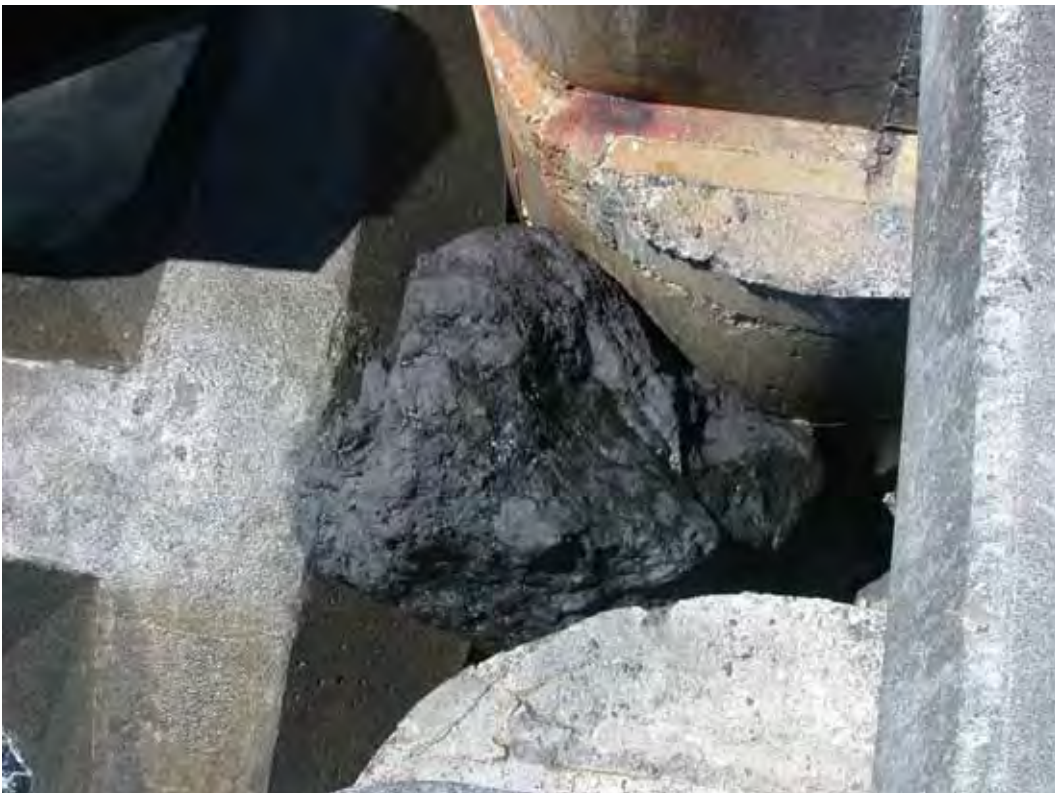
Figure C14. Displaced armor stone, tossed onto dolos.

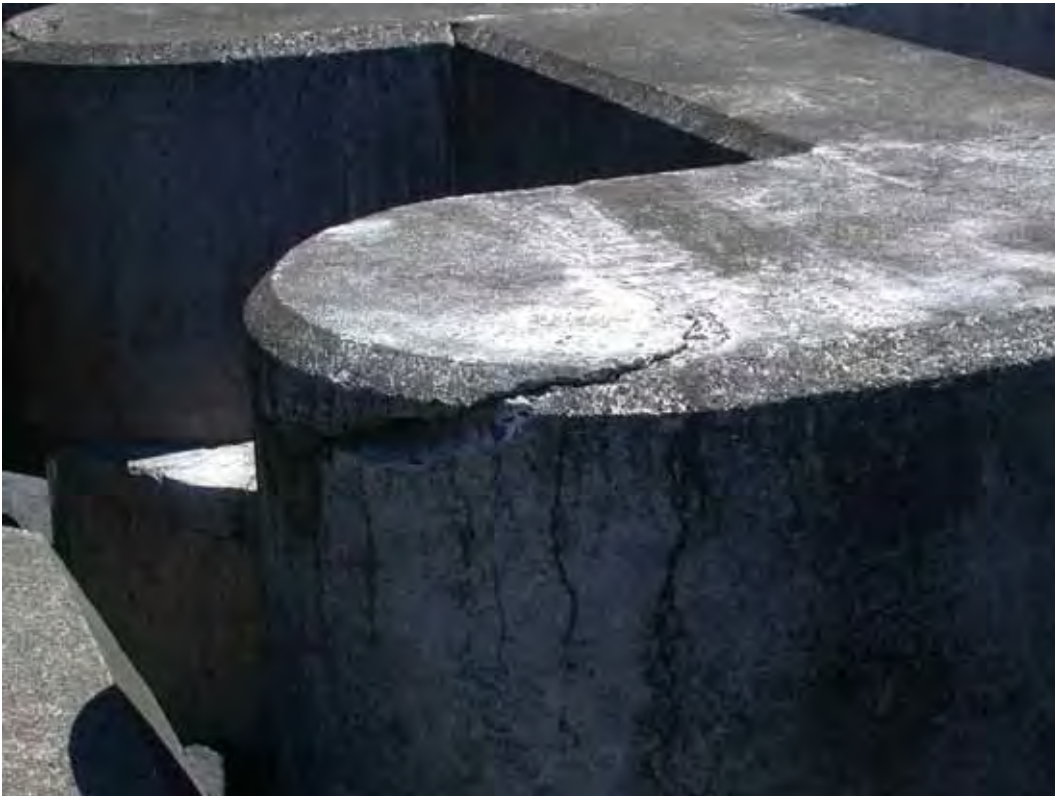
Figure C15. Rib #9, cracked.

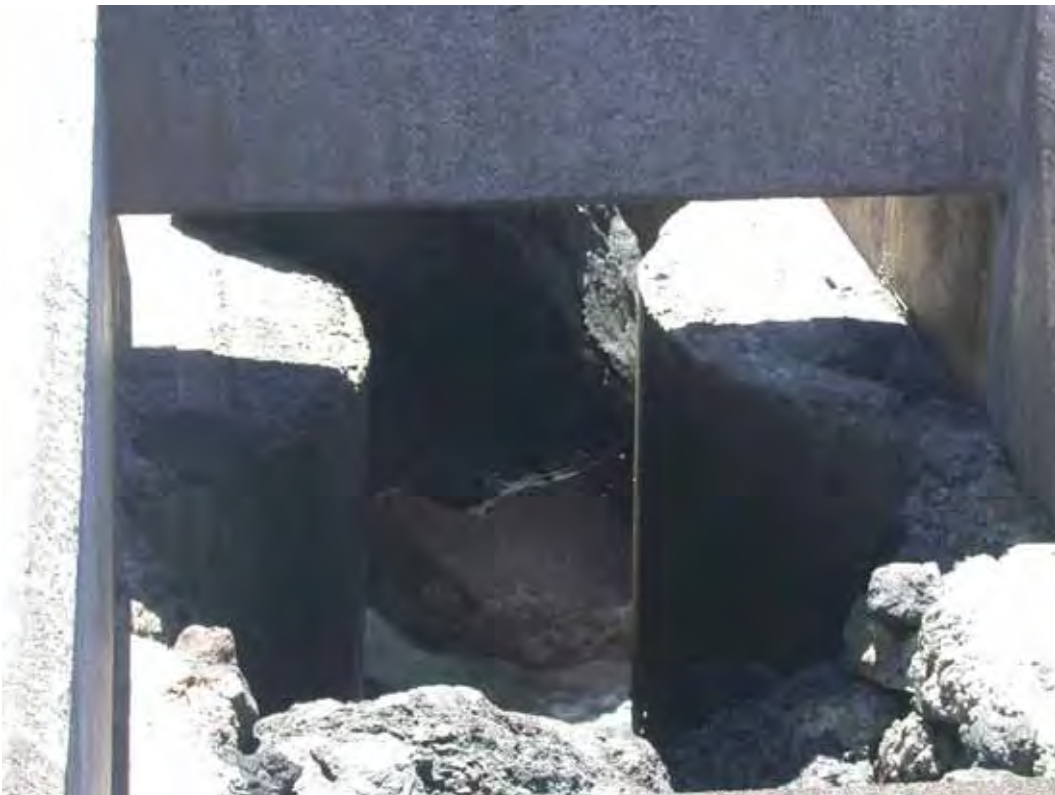
Figure C16. Underlayer loss and shifting of stones between ribs.

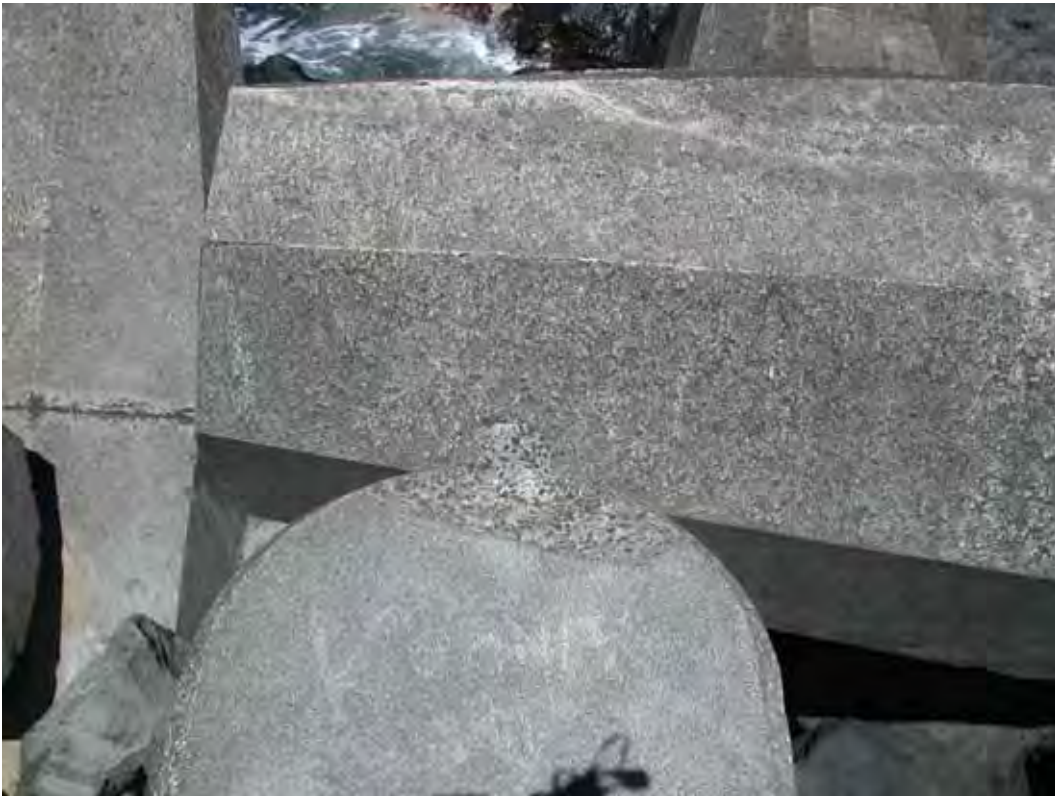
Figure C17. Rib damage possibly caused by displaced armor stones.

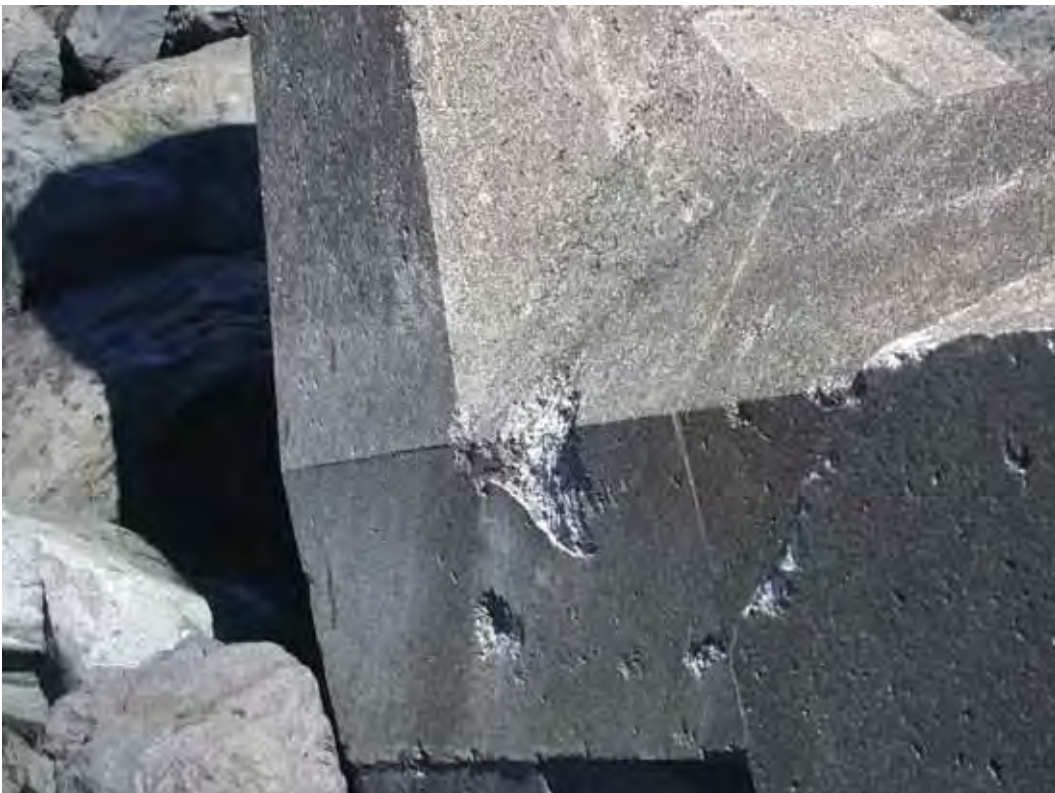
Figure C18. dolosse damage possibly caused by displaced armor stones.

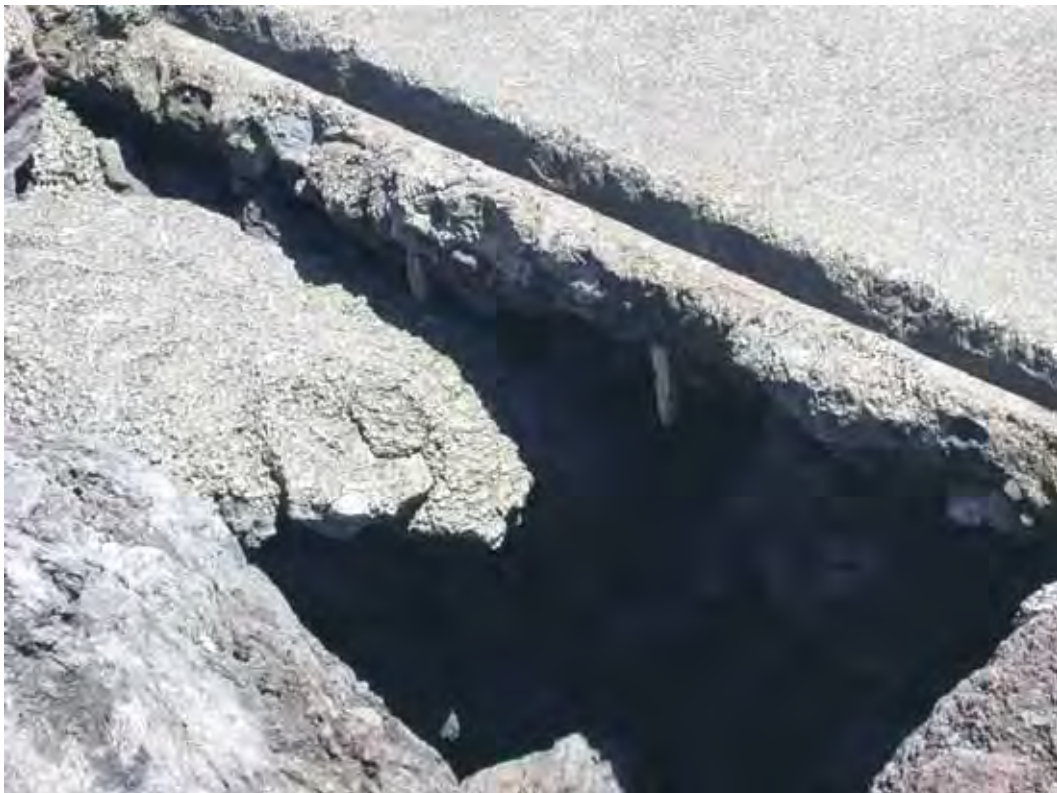
Figure C20. Undermining of concrete slab adjacent to breakwater and boat launch.

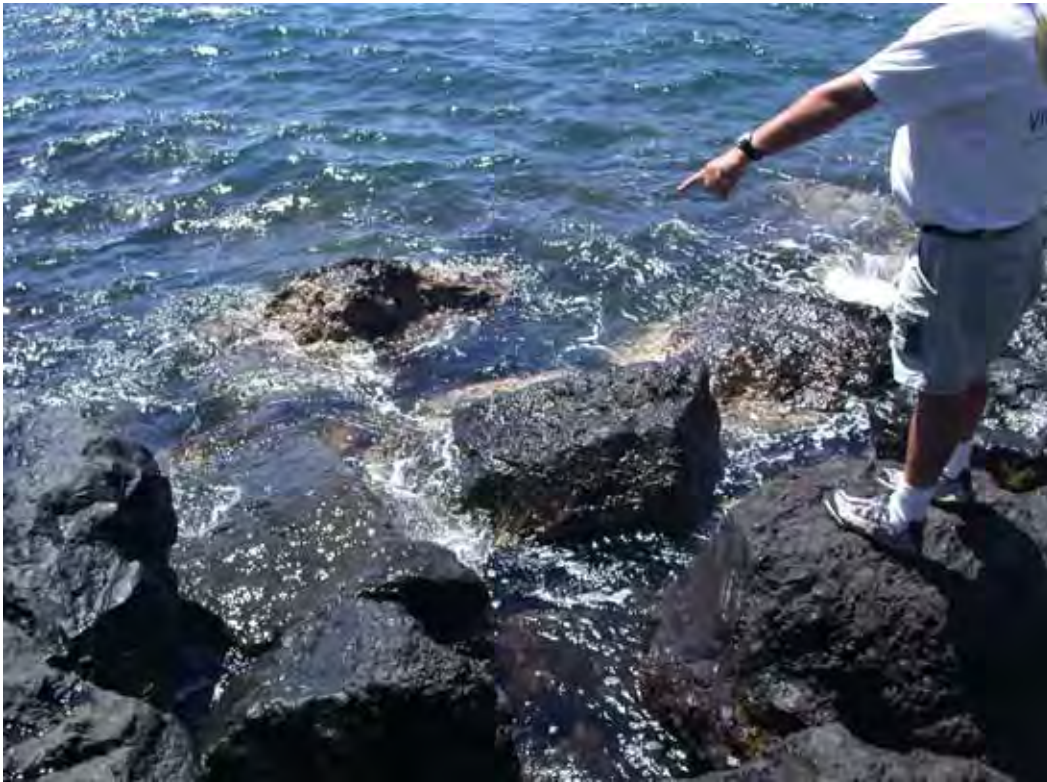
Figure C21. Displaced armor stones at wave absorber along shoreline, harbor side of breakwater.

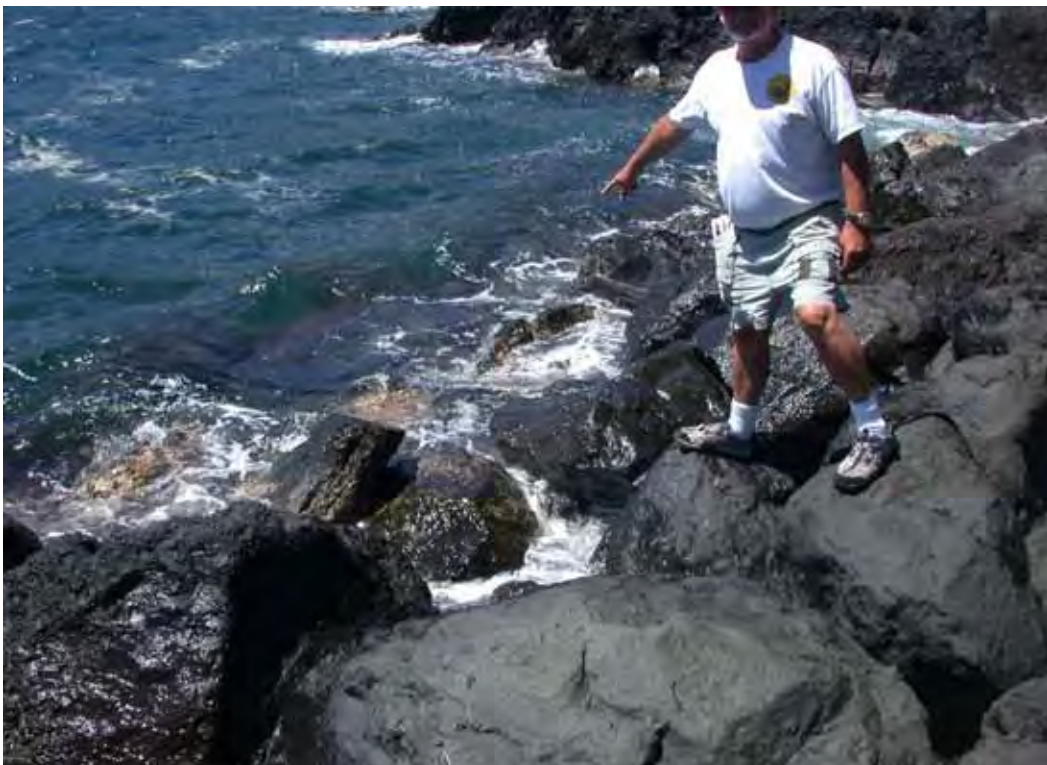
Figure C22. Displaced armor stones at wave absorber along shoreline, harbor side of breakwater.

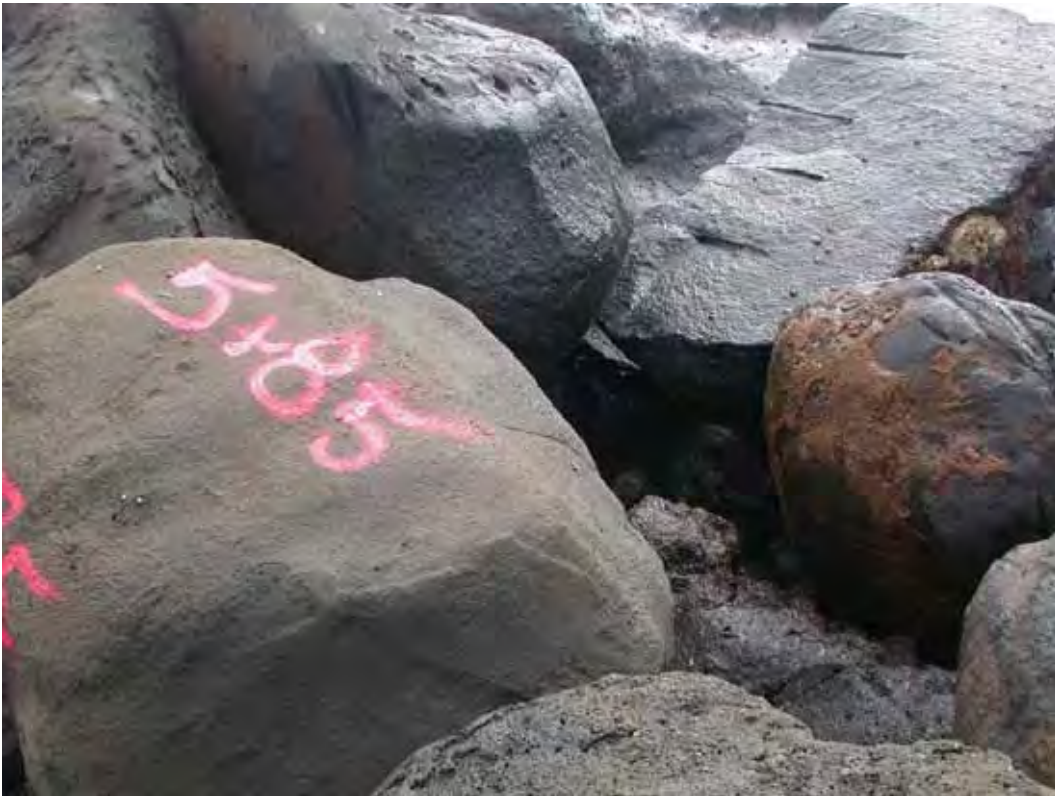
Figure D5. Damage location 4, sta 5+85, ocean side, void on side slope.

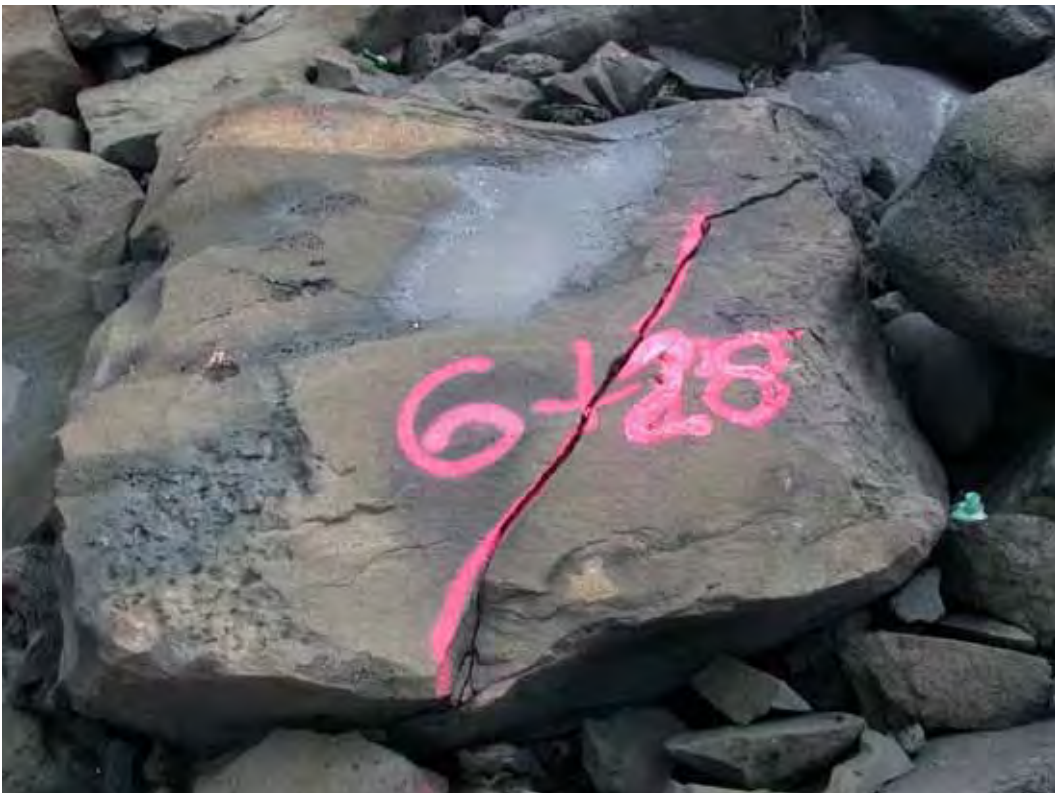
Figure D6. Damage location 5, sta 6+28, cracked armor stone on crest.

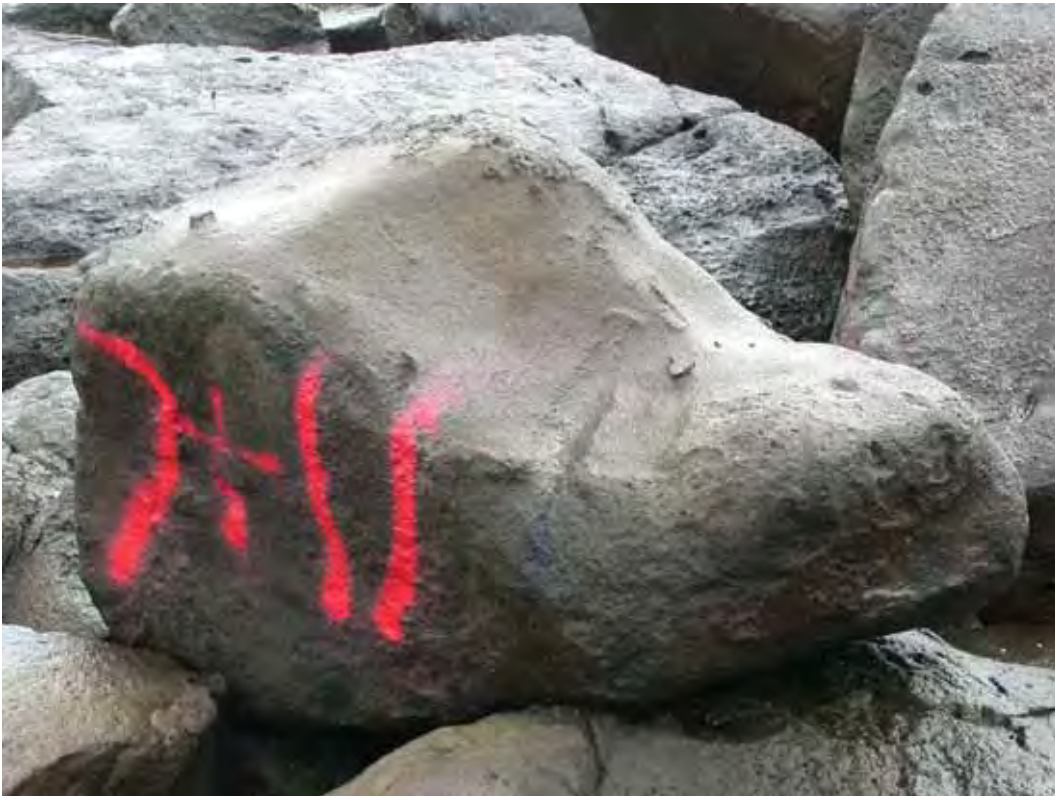
Figure D9. Damage location 8, sta 7+11, perched armor stone on crest.

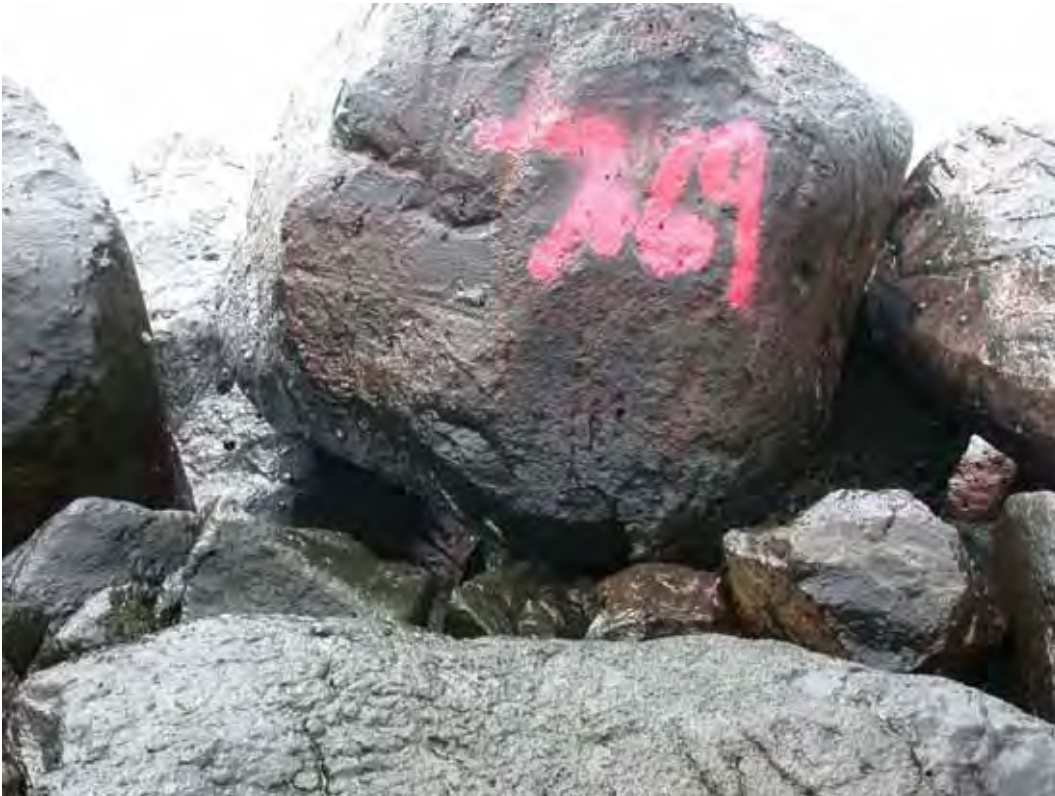
Figure D11. Damage location 10, sta 7+69, ocean side, bridging.

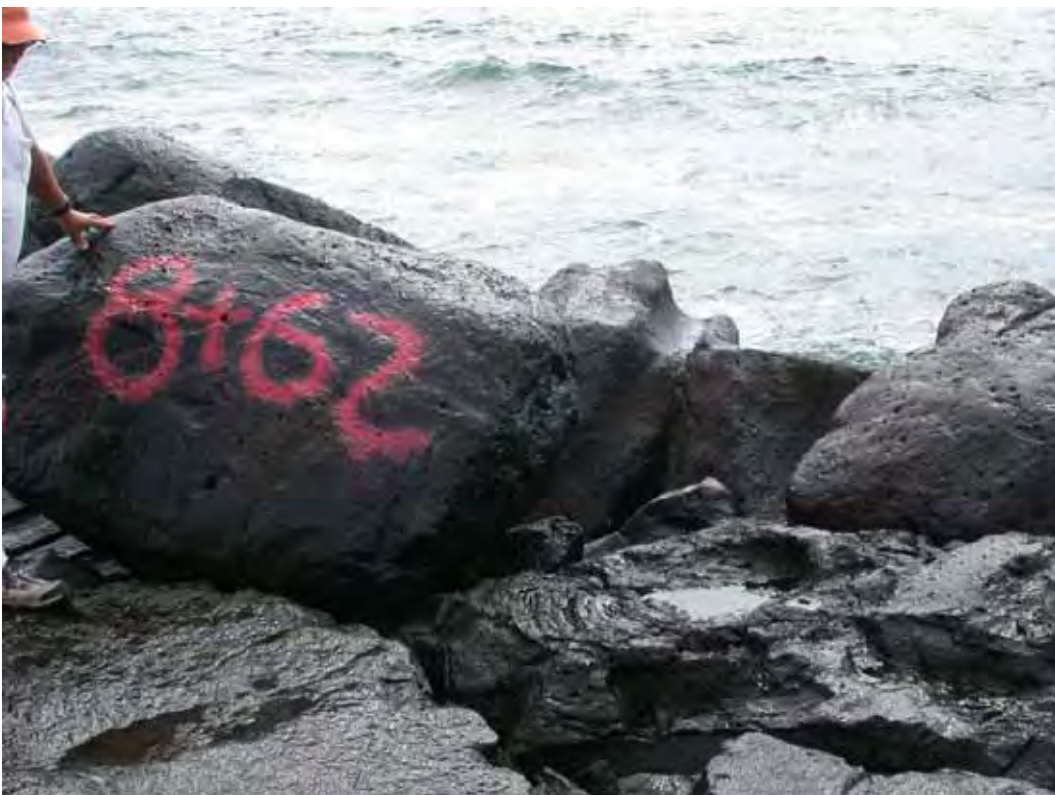
Figure D12. Damage location 11, sta 8+62, ocean side, perched armor stone with void.

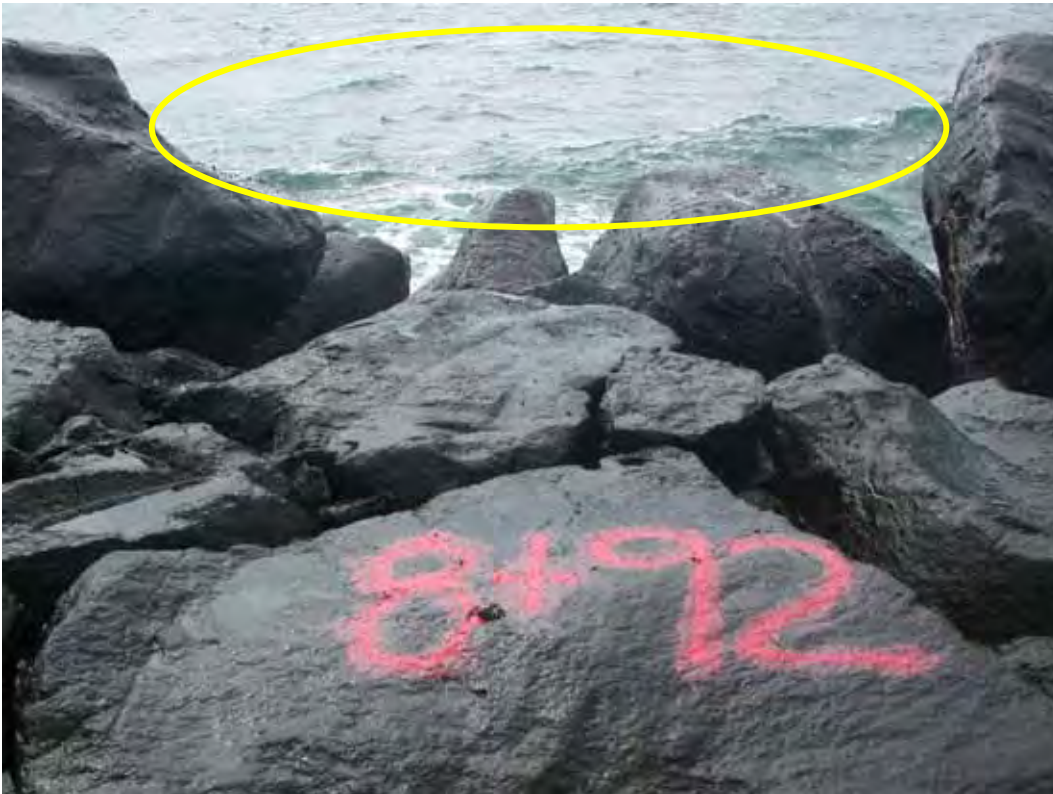
Figure D13. Damage location 12, sta 8+92, ocean side, void.

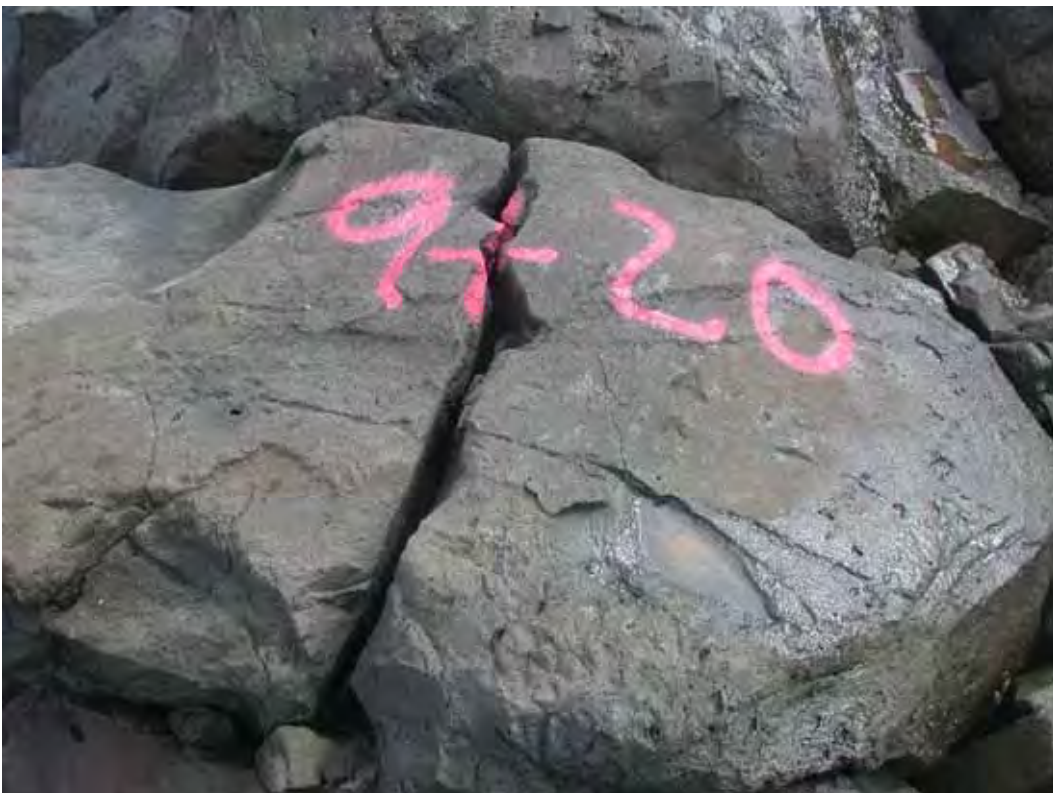
Figure D14. Damage location 13, sta 9+20, harbor side, cracked armor stone at hinge.

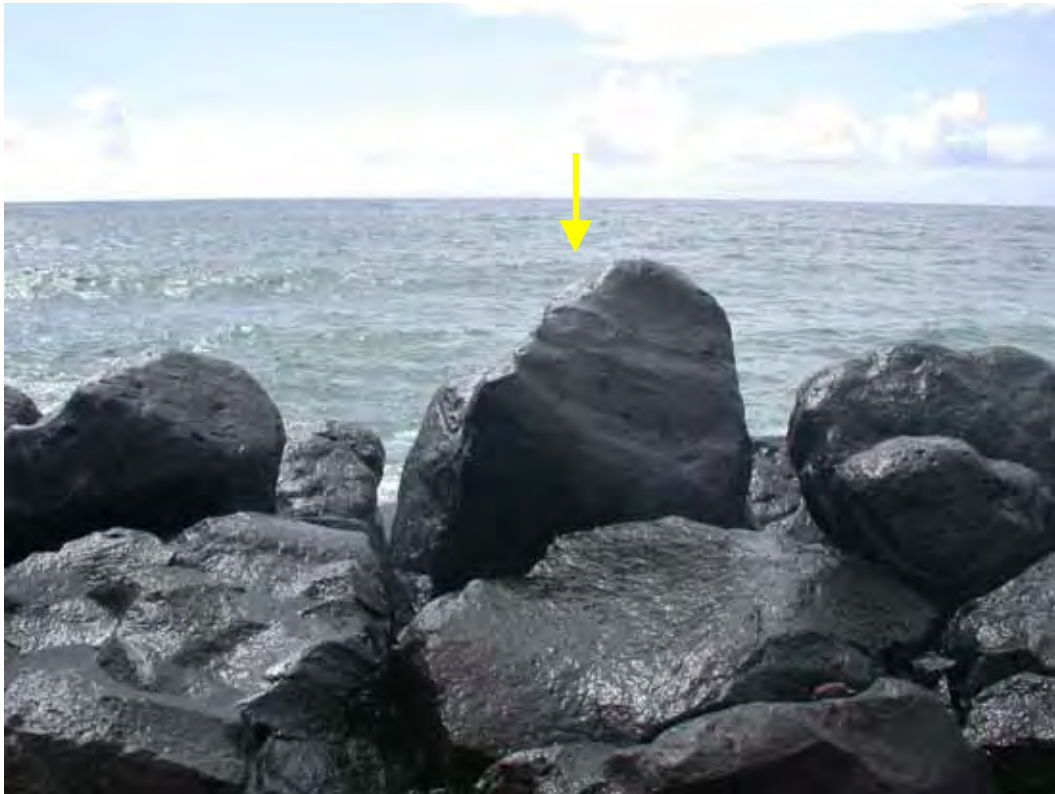
Figure D15. Damage location 14, sta 9+20, ocean side, flipped armor stone and void.

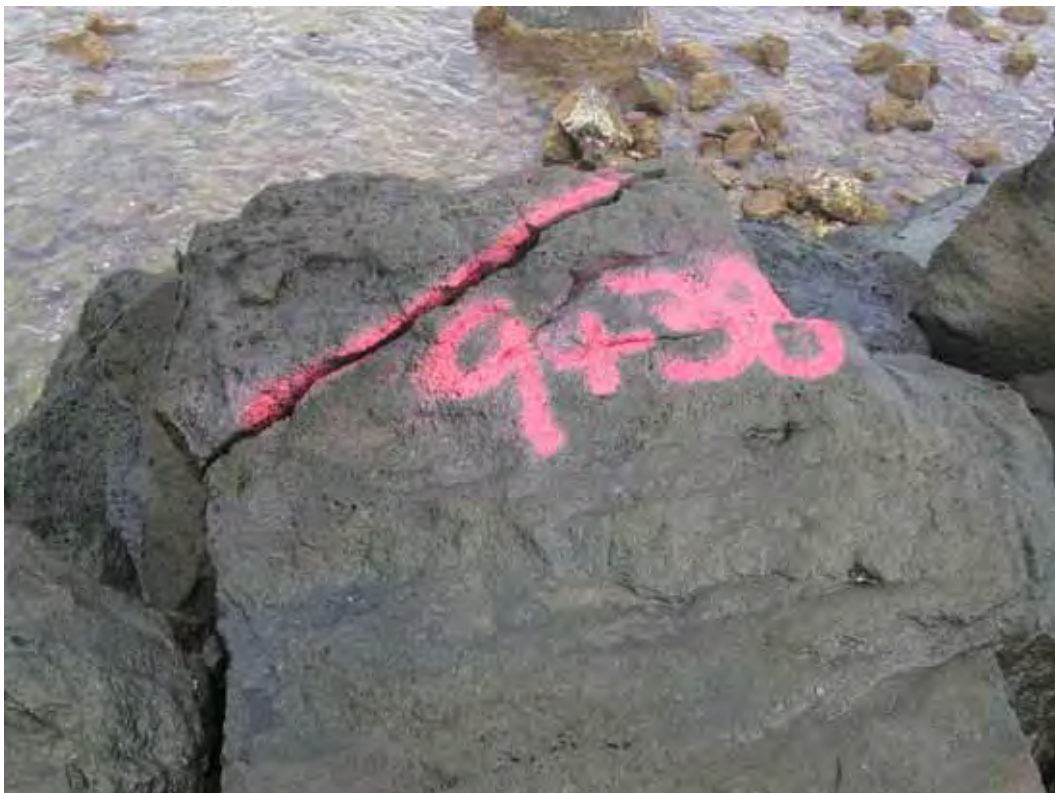
Figure D16. Damage location 15, sta 9+38, harbor side, cracked armor stone at hinge.

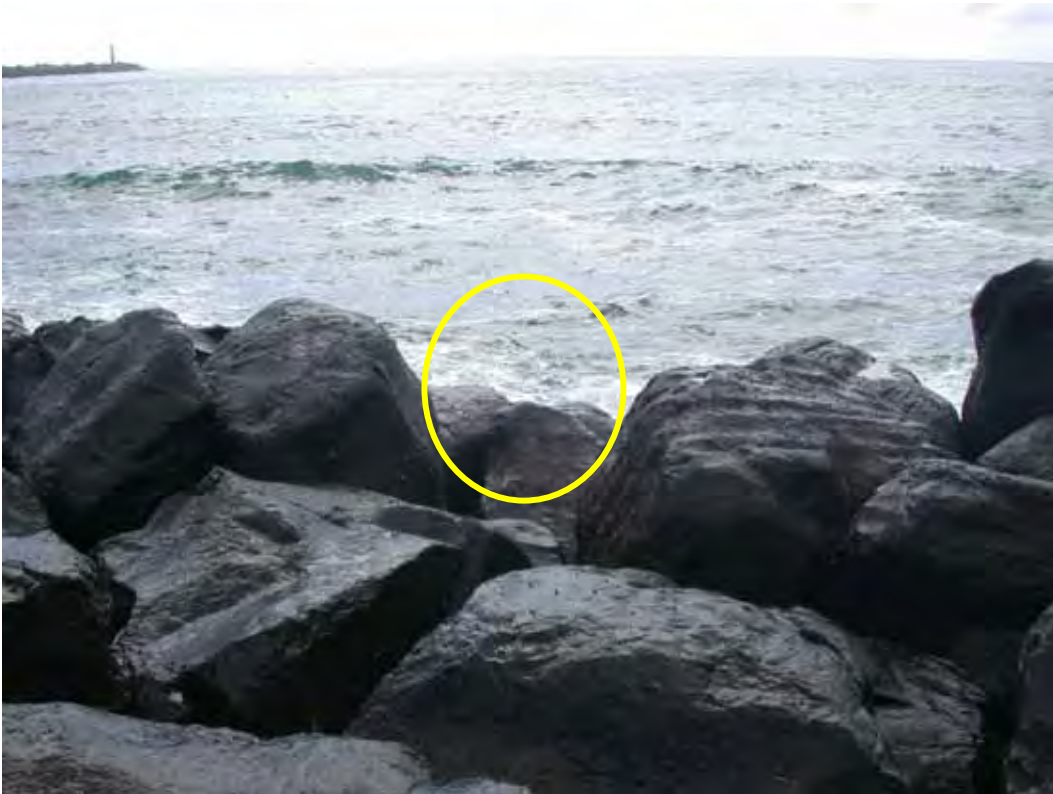
Figure D17. Damage location 16, sta 9+67, ocean side, void at hinge.

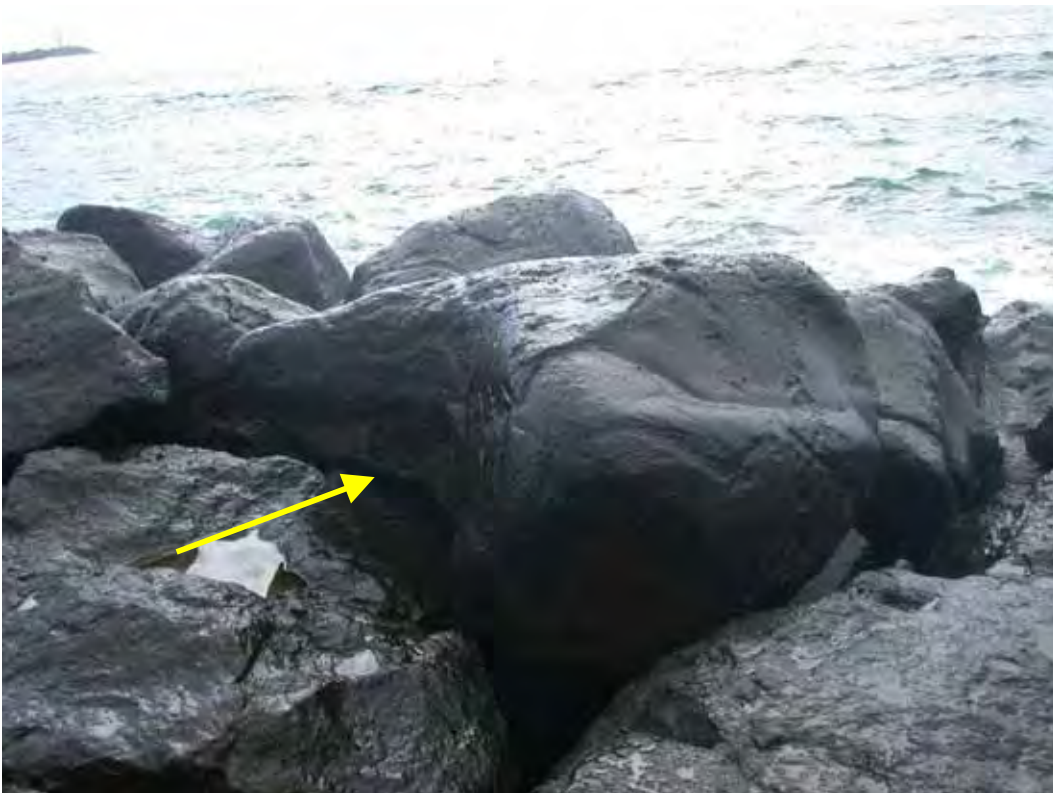
Figure D18. Damage location 17, sta 9+87, ocean side, perched armor stone.

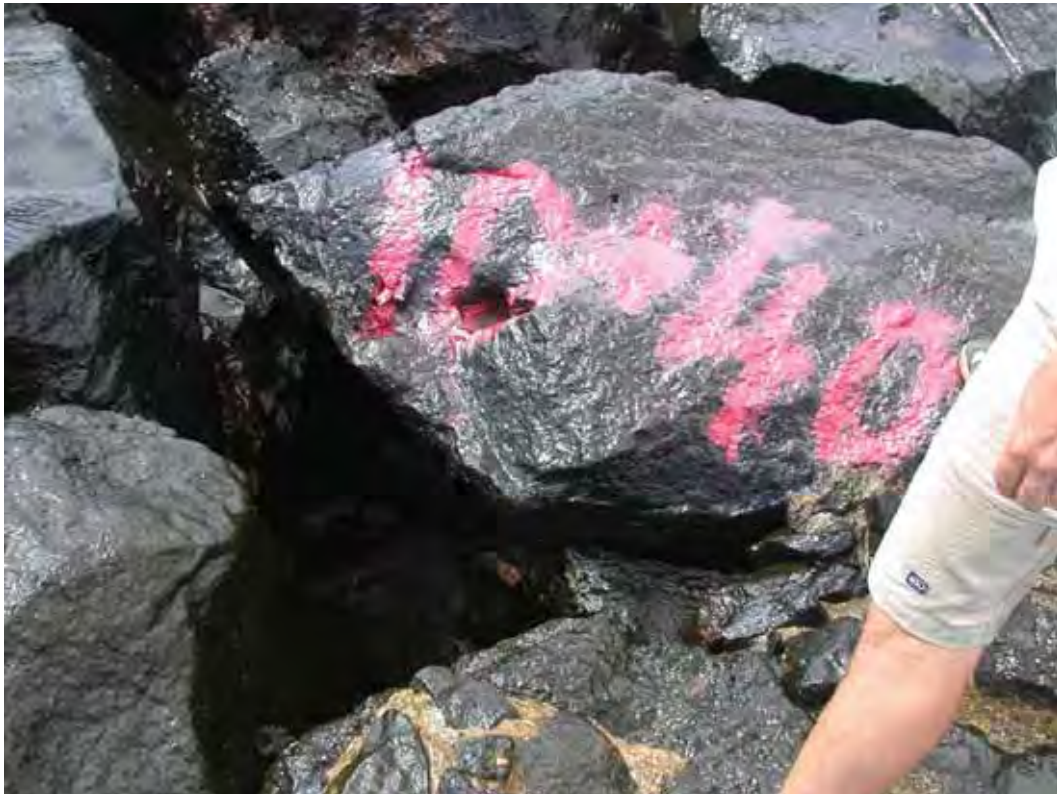
Figure D21. Damage location 20, sta 10+40, void (depth to waterline) at centerline of crest.

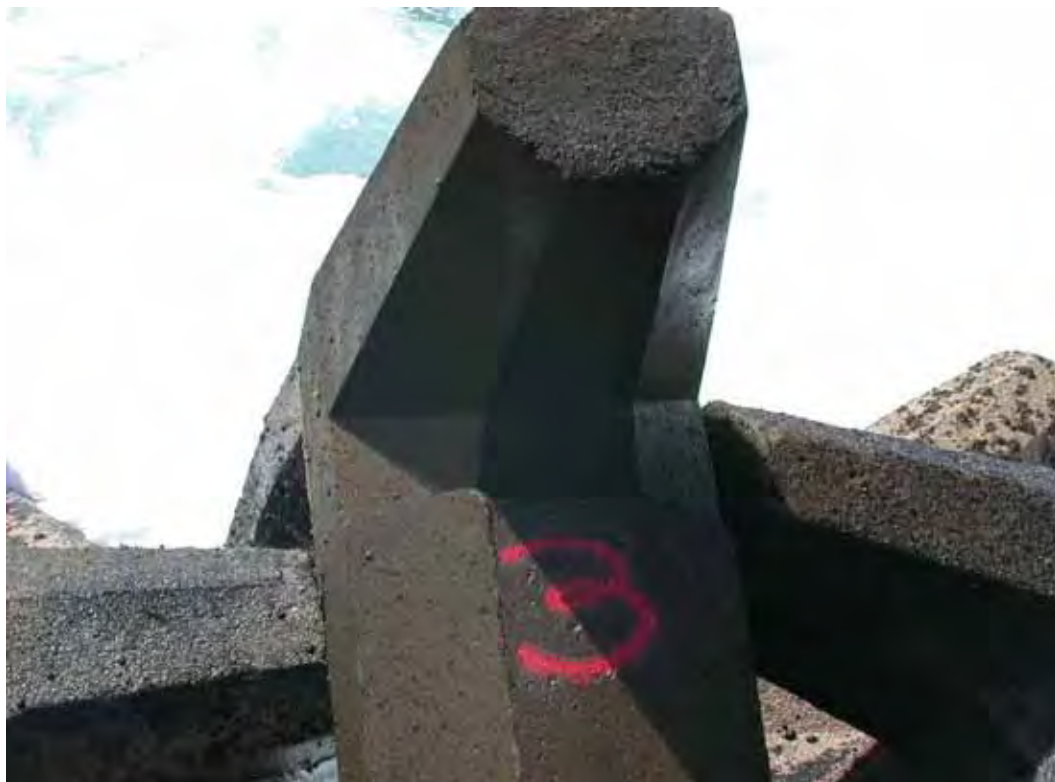
Figure D25. Damage location 26, sta 12+06, ocean side, rib #2, dolosse with shank-fluke break.

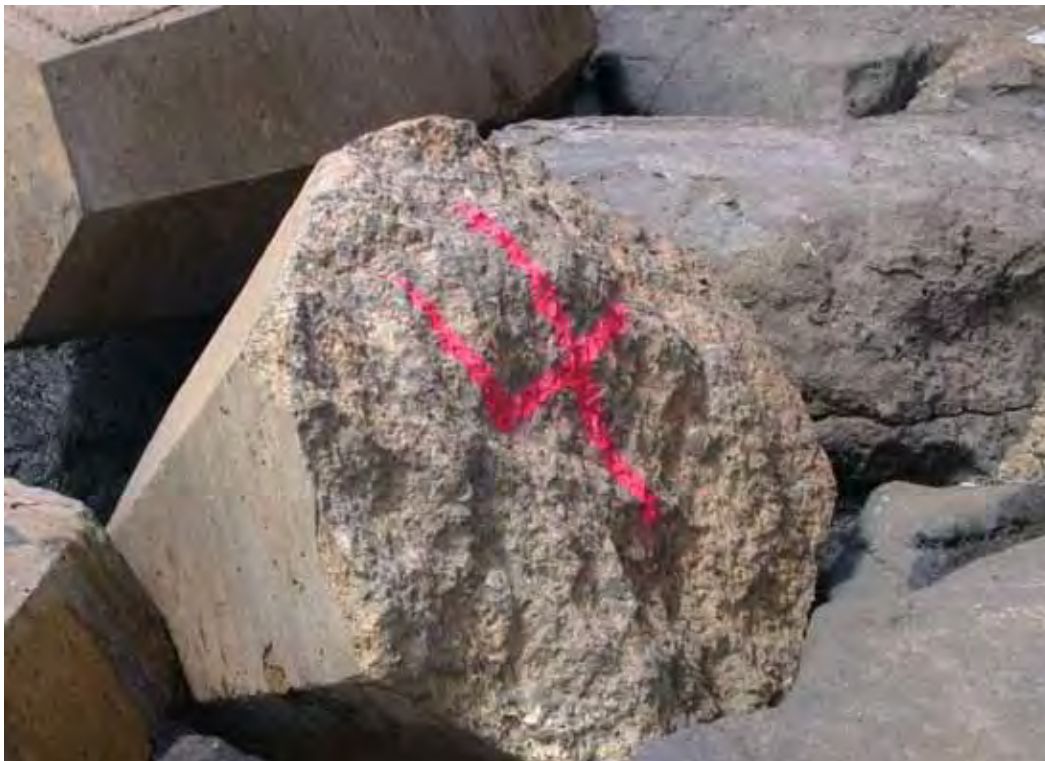
Figure D27. Damage location 28, sta 12+30, ocean side, rib #6, detached dolosse fluke tip, origin unknown.

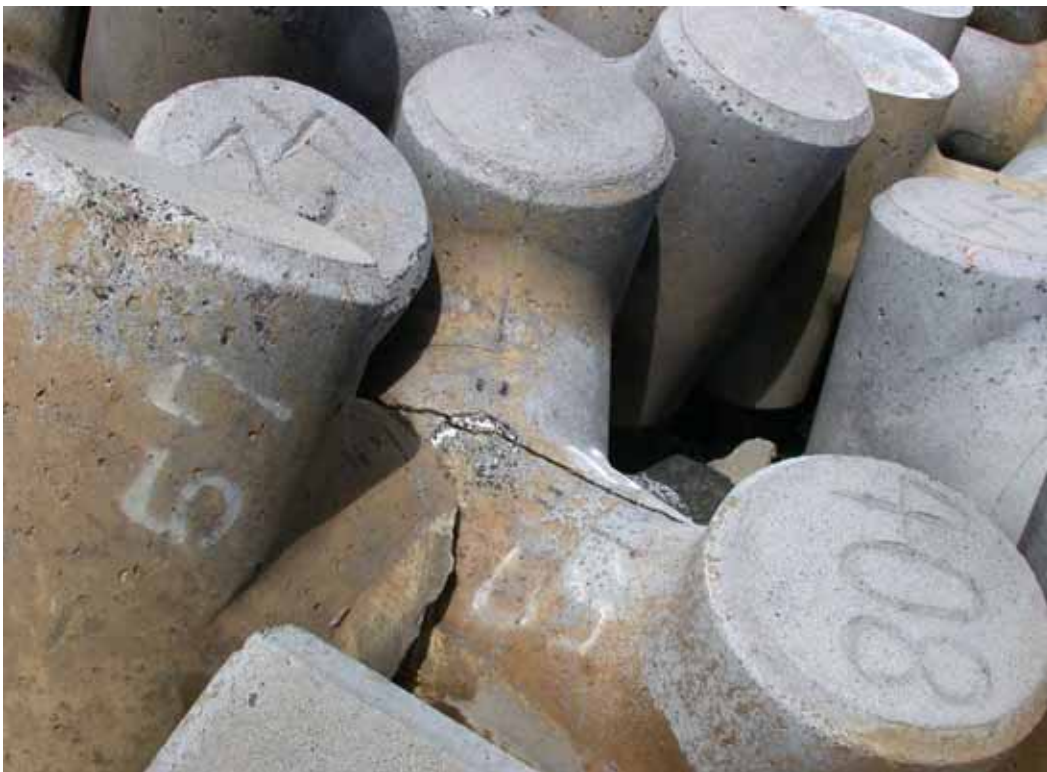
Figure D31. Damage location 34, sta 12+90, harbor side, rib #16, tribar with leg broken at center.

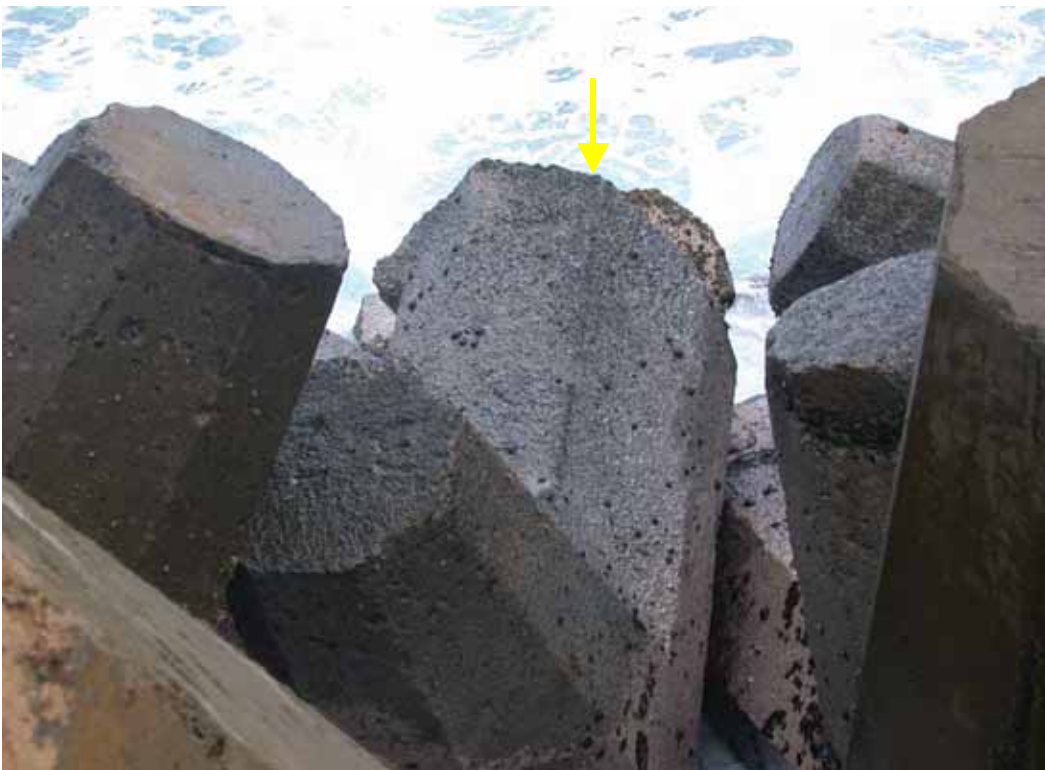
Figure D35. Damage location 40, sta 13+80, ocean side, rib #31, dolosse with shank-fluke break at waterline.

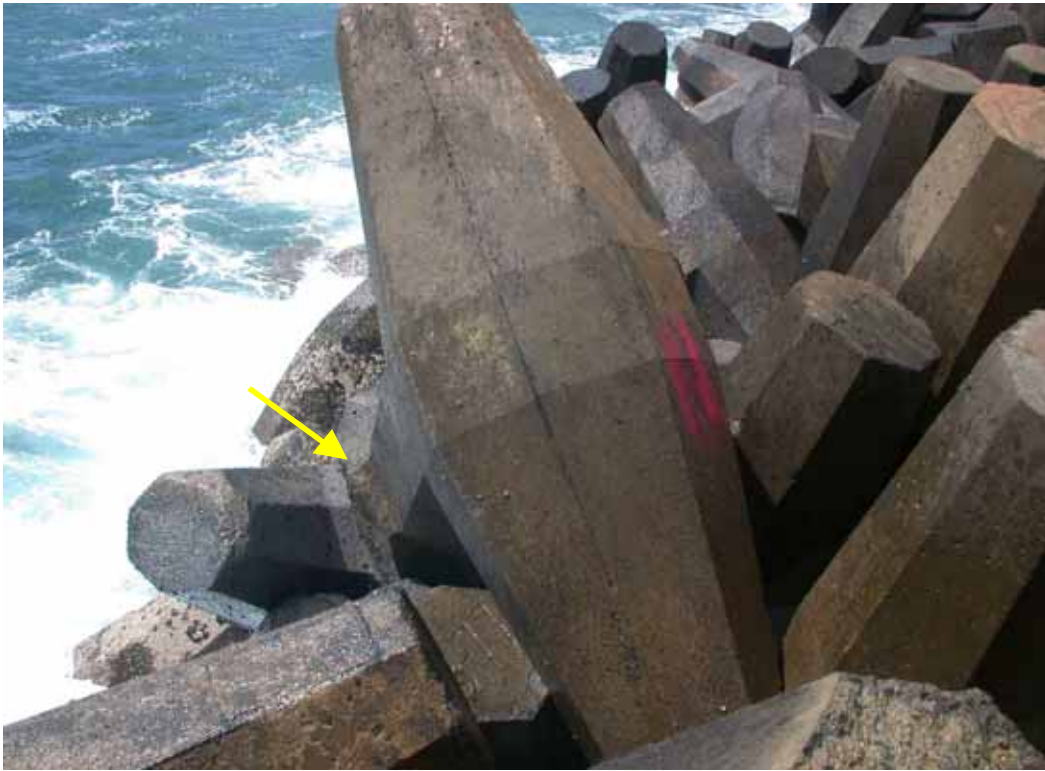
Figure D36. Damage location 41, sta 13+92 – 13+98, ocean side, rib #33 & 34, dolosse with fluke-shank break.

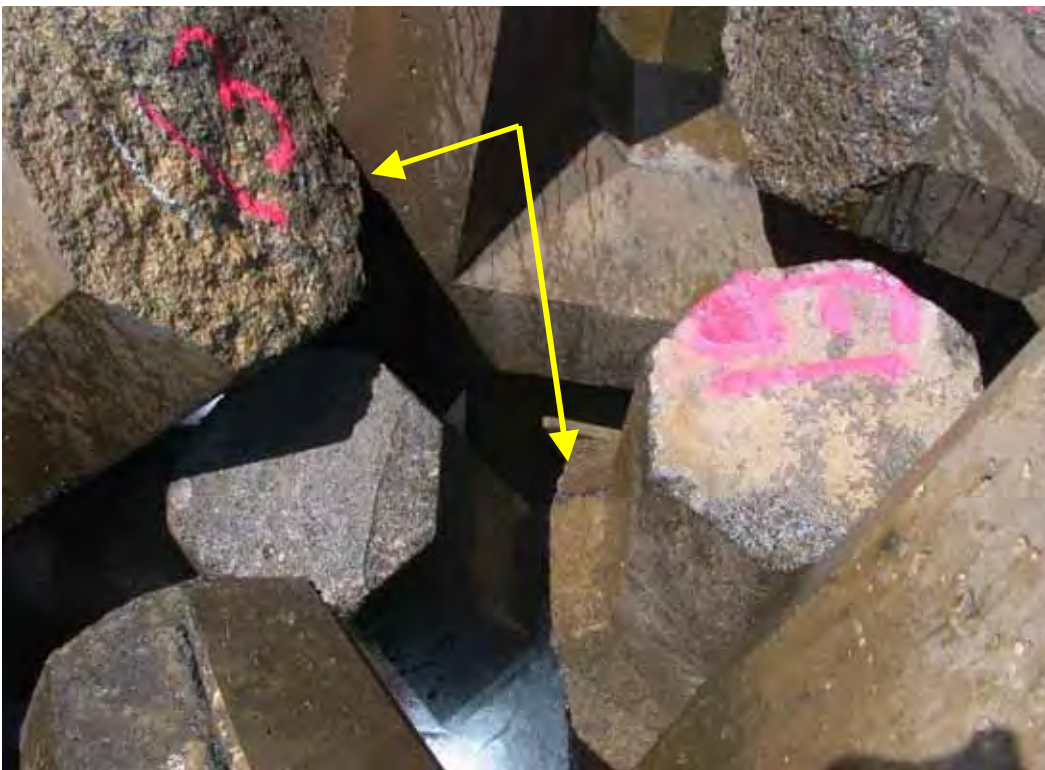
Figure D37. Damage location 43, sta 14+04, ocean side, rib #35, dolosse with mid-shank break.

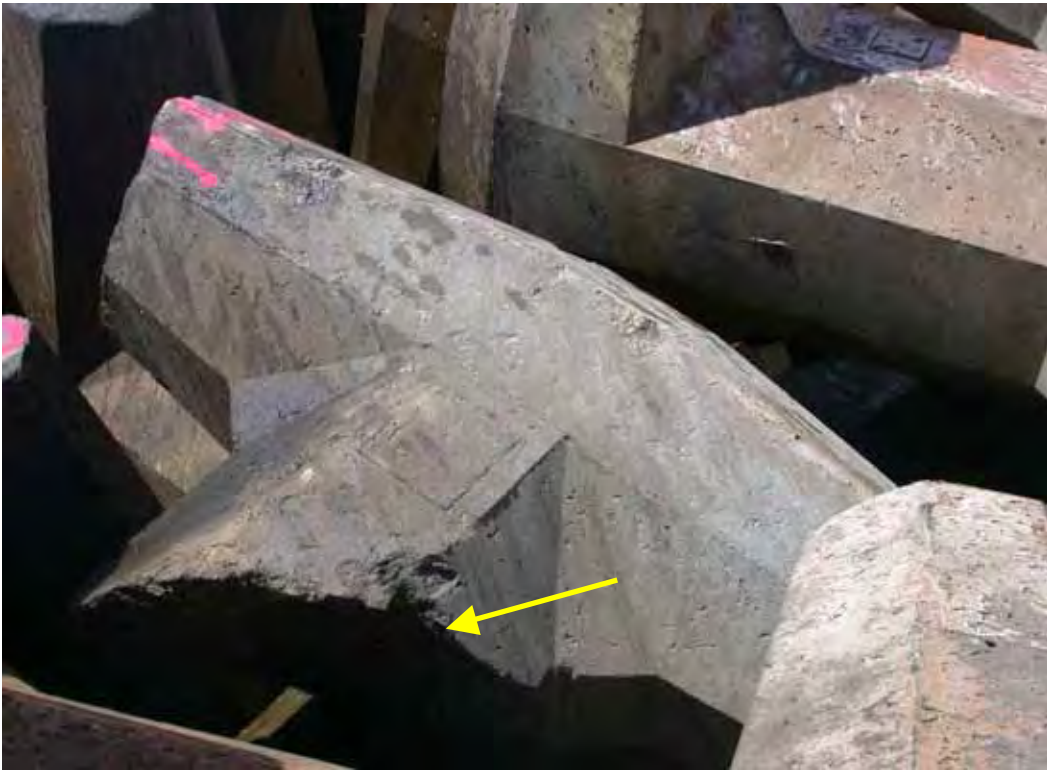
Figure D38. Damage location 44, sta 14+04, ocean side, rib #35, dolosse with mid-shank break.
